# New Hampshire Volunteer Lake Assessment Program

## 2002 Bi-Annual Report for Millen Pond Washington

NHDES  
Water Division  
Watershed Management Bureau  
6 Hazen Drive  
Concord, NH 03301

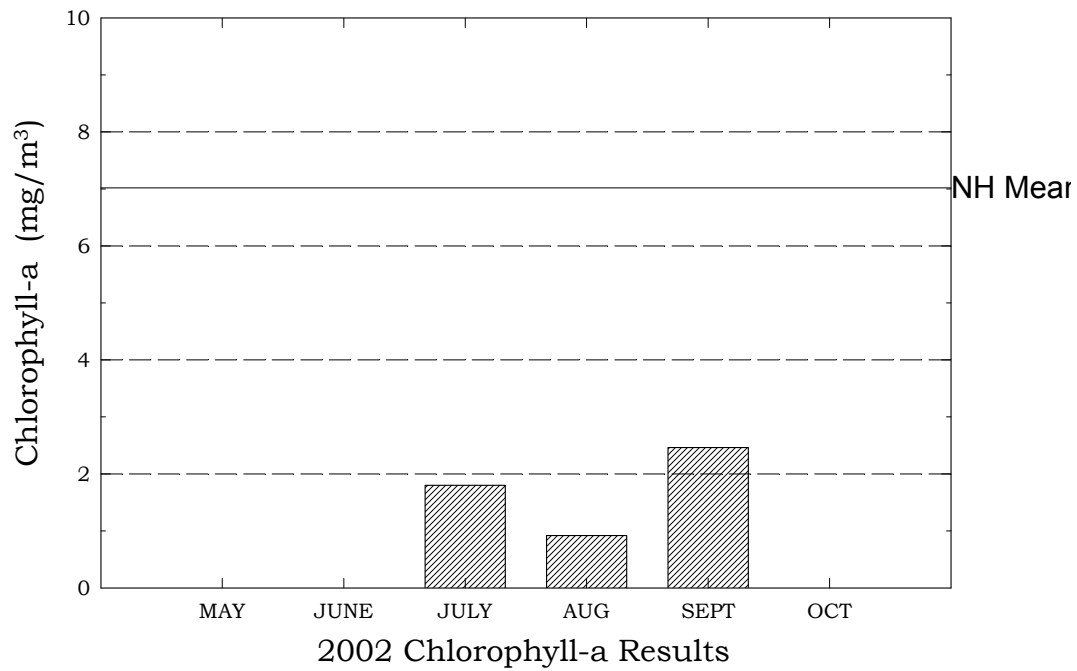
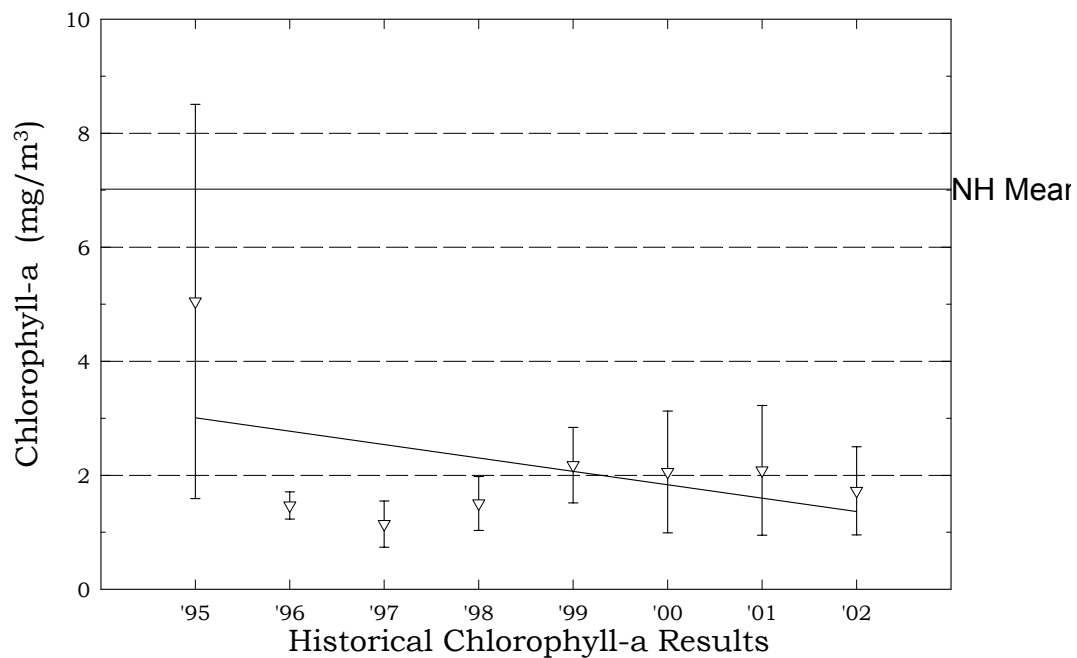
**Figure 1.** Monthly and Historical Chlorophyll-a Results

- **Figure 1 and Table 1:** The graphs in Figure 1 (Appendix A) show the historical and current year chlorophyll-a concentration in the water column. Table 1 (Appendix B) lists the maximum, minimum, and mean concentration for each sampling season that the lake/pond has been monitored through the program.

The current year data (the top graph) show that the chlorophyll-a concentration **decreased** from July to August, and then **increased** from August to September.

The historical data (the bottom graph) show that the 2002 chlorophyll-a mean is ***much less than*** the state mean.

Overall, visual inspection of the historical data (the bottom graph) shows **a slightly decreasing (meaning slightly improving)** chlorophyll-a trend since monitoring began in 1995. However, if the elevated 1995 mean is excluded, concentration has **remained approximately the same**, and **much less than** the state mean, since 1996. We hope this trend continues!

While algae are naturally present in all lakes/ponds, an excessive or increasing amount of any type is not welcomed. In freshwater lakes/ponds, phosphorus is the nutrient that algae depend upon for growth. Therefore, algal concentrations may increase when there is an increase in nonpoint sources of nutrient loading from the watershed, or in-lake sources of phosphorus loading (such as phosphorus releases from the sediments). It is important to continually educate residents about how activities within the watershed can affect phosphorus loading and lake quality.

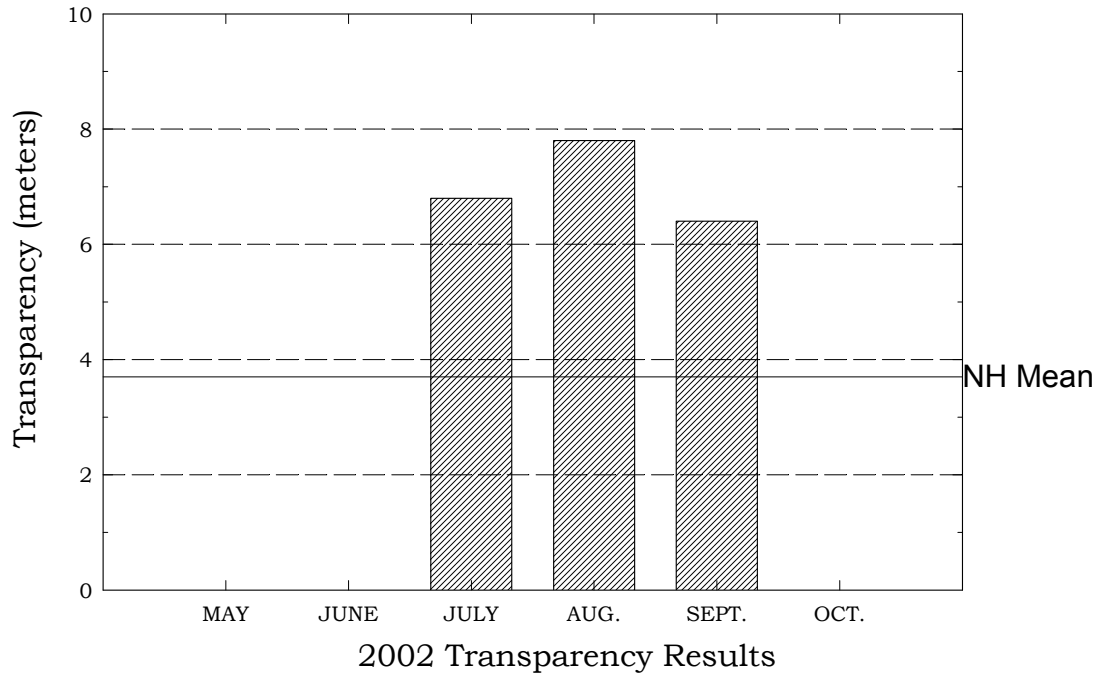
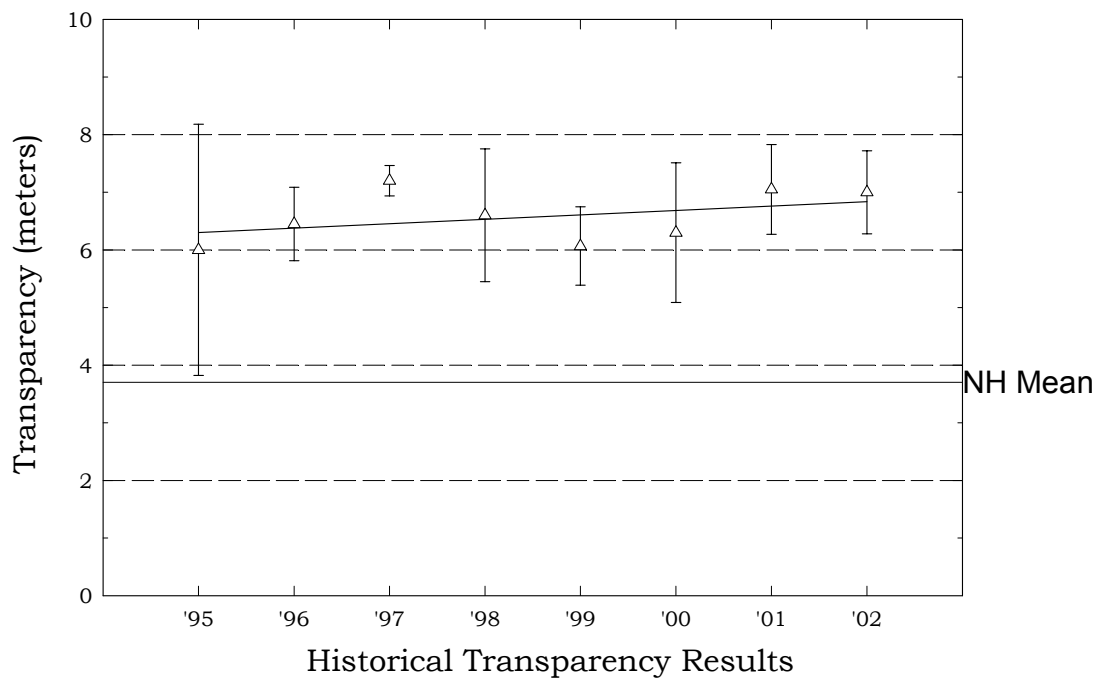
**Figure 2.** Monthly and Historical Transparency Results

- **Figure 2 and Table 3:** The graphs in Figure 2 (Appendix A) show historical and current year data for lake/pond transparency. Table 3 lists the maximum, minimum and mean transparency data for each sampling season that the lake/pond has been monitored through the program.

The current year data (the top graph) show that the in-lake transparency **increased** from July to August, and then **decreased** from August to September. It is worthy to note that as the chlorophyll concentration *decreased* from July to August, the transparency *increased*, and as the chlorophyll *increased* from August to September, the transparency *decreased*. We expect this inverse relationship in lakes. As the amount of algal cells in the water *decreases*, the depth to which one can see into the lake typically *increases*.

The historical data (the bottom graph) show that the 2002 mean transparency is ***much greater than*** the state mean.

Overall, visual inspection of the historical data trend line (the bottom graph) shows ***a slightly increasing*** trend for in-lake transparency, meaning that the transparency has ***slightly improved*** since monitoring began in 1995.

Typically, high intensity rainfall causes erosion of sediments into lakes/ponds and streams, thus decreasing clarity. Efforts should continually be made to stabilize stream banks, lake/pond shorelines, disturbed soils within the watershed, and especially dirt roads located immediately adjacent to the edge of tributaries and the lake/pond. Guides to Best Management Practices designed to reduce, and possibly even eliminate, nonpoint source pollutants, such as sediment loading, are available from NHDES upon request.

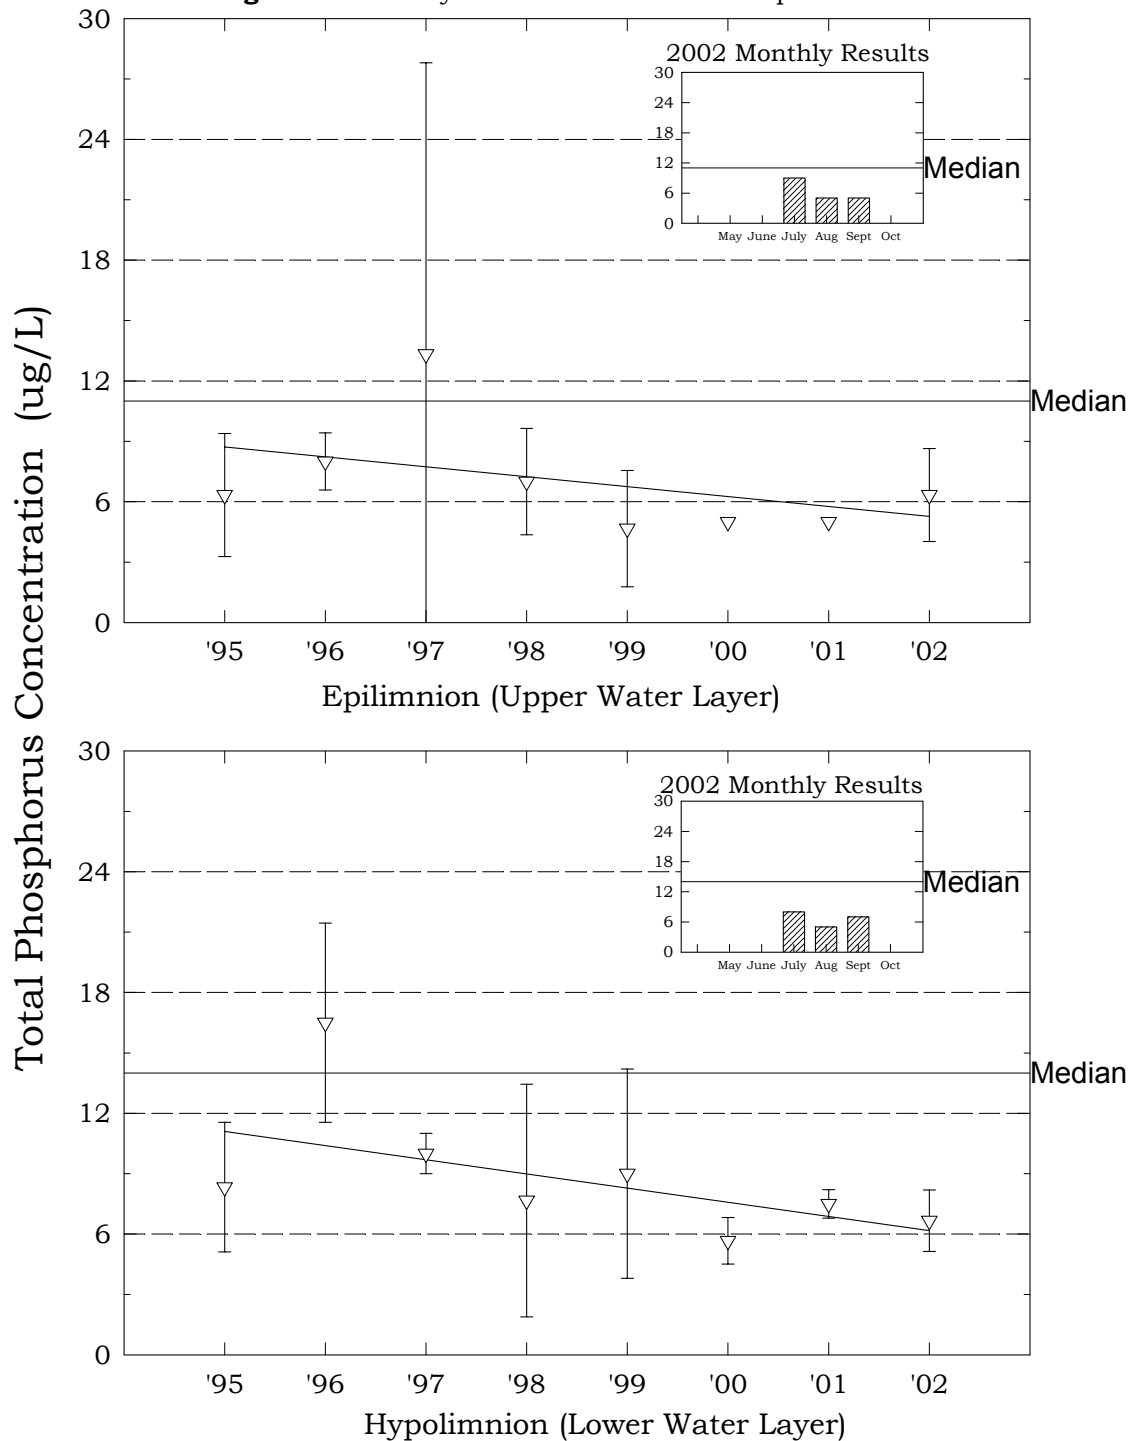
**Figure 3.** Monthly and Historical Total Phosphorus Data.

- **Figure 3 and Table 8:** The graphs in Figure 3 (Appendix A) show the amounts of phosphorus in the epilimnion (the upper layer) and the hypolimnion (the lower layer); the inset graphs show current year data. Table 8 (Appendix B) lists the annual maximum, minimum, and median concentration for each deep spot layer and each tributary since the lake/pond has joined the program.

The current year data for the epilimnion (the top inset graph) show that the total phosphorus concentration **decreased** from July to August, and then remained **approximately stable** from August to September.

The current year data for the hypolimnion (the bottom inset graph) show that the total phosphorus concentration **decreased slightly** from June to August, and then **increased slightly** from August to September.

The historical data show that the 2002 mean epilimnetic (the upper graph) and the hypolimnetic (the lower graph) total phosphorus concentration is **less than** the state median.

Overall, visual inspection of the historical data trend line for the epilimnion and the hypolimnion show **a decreasing** total phosphorus trend, which means that the concentration has **slightly improved** in since monitoring began. We hope this trend continues!

One of the most important approaches to reducing phosphorus loading to a waterbody is to continually educate watershed residents about its sources and how excessive amounts can adversely impact the ecology and value of lakes and ponds. Phosphorus sources within a lake or pond's watershed typically include septic systems, animal waste, lawn fertilizer, road and construction erosion, and natural wetlands. If you would like to educate watershed residents about how they can help to reduce phosphorus loading into the lake/pond, please contact the VLAP Coordinator.
